District of Squamish
37955 Second Avenue
P.O. Box 310
V8B 0A3

May 5, 2015
File: 12942

Re: Preliminary Geotechnical Review, Angels Crest Rock Fall, Stawamus Chief, Squamish, BC

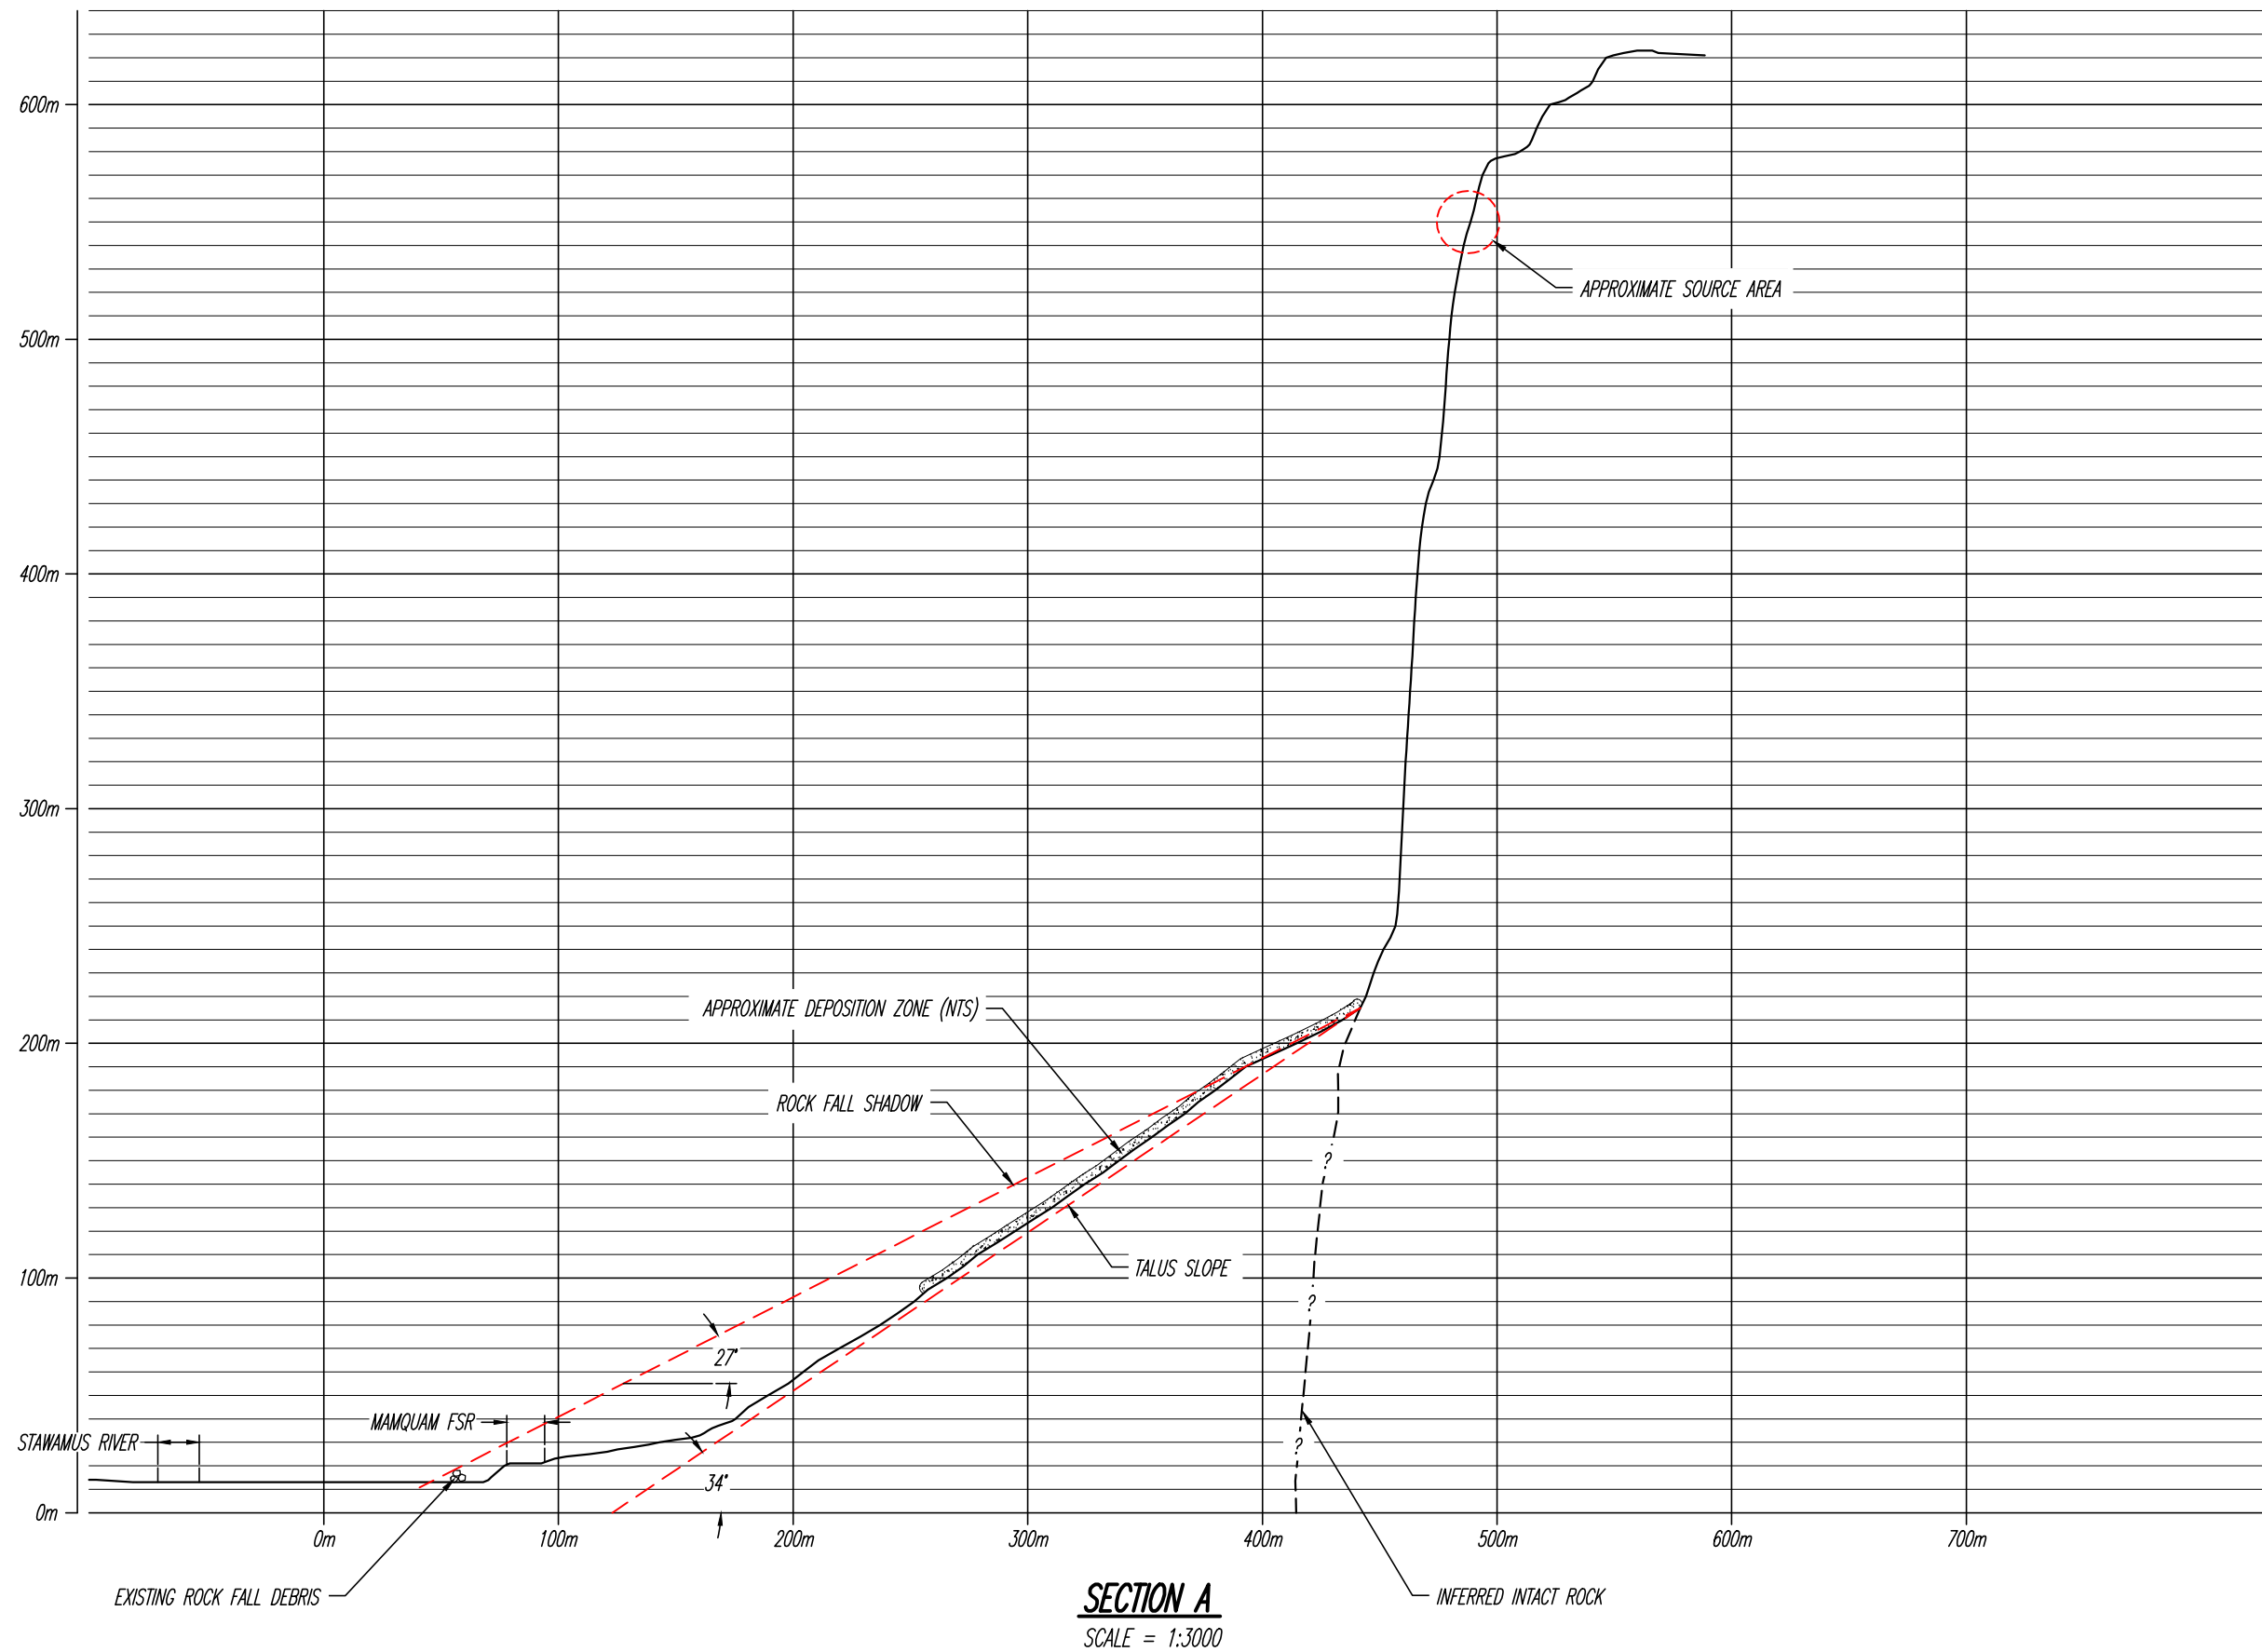
DWG. NO.: G-SEC1

At the location of the rock fall The Chief rises almost vertically as can be seen on the Section included in Appendix A. There is an apron about 30 m high, which projects about 10 m outward from the base of the wall, on to which it appears that much of the falling rock impacted prior to breaking up and bouncing and rolling, and destroying the existing forest cover and being distributed over the existing talus.

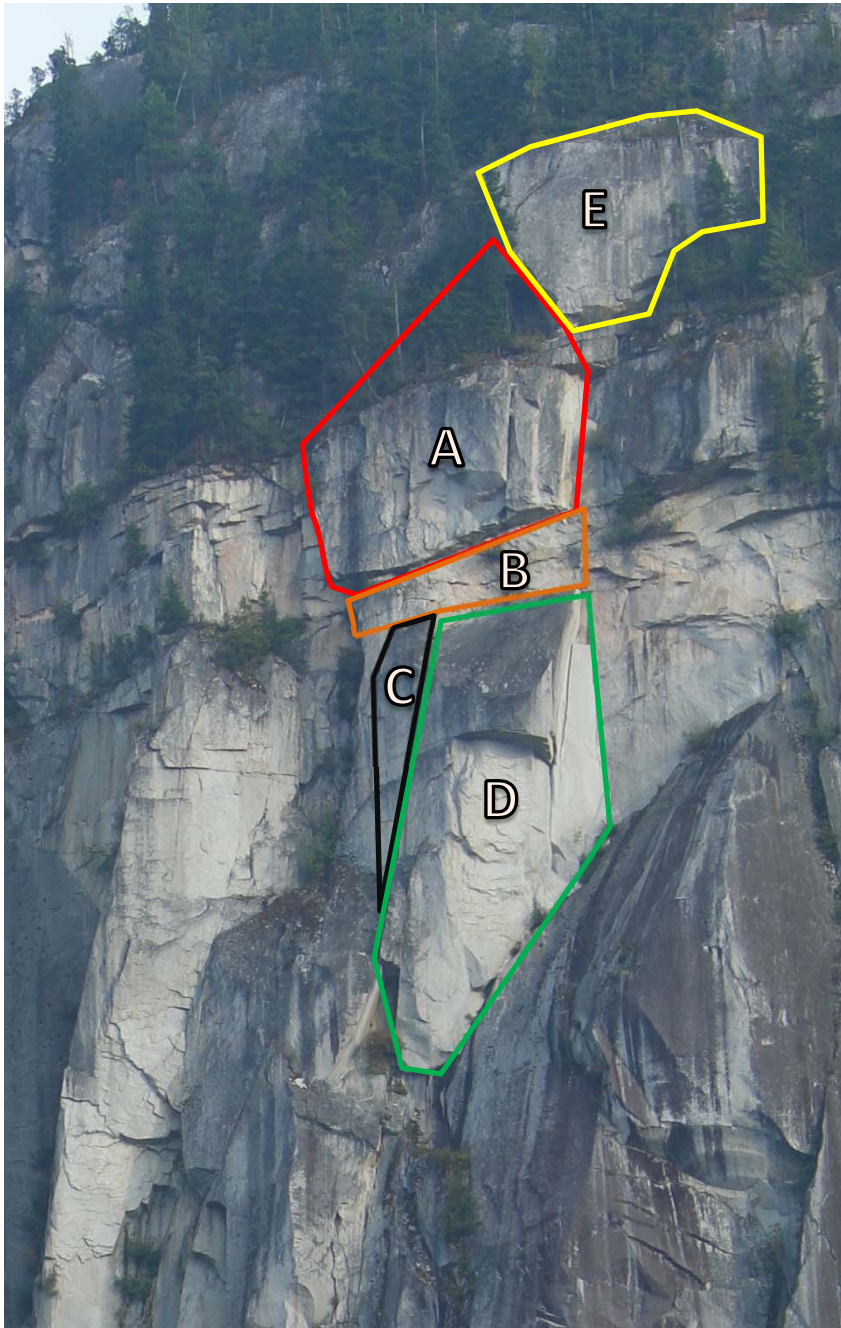
At the source area there was a major near vertical back release plane (natural joint or fracture) that trends approximately parallel with North Wall that now forms the back scarp of the failure. Review of photographs taken before the rock fall shows that the failed block (Block A) contained, and was flanked on either side by side release joints dipping about 75 degrees to the northeast (near perpendicular to the rock face) and that there was a major joint that dips about 10 degrees to the northeast at the base of the block (ref. Figure 1). We estimate that the failed block protruded beyond the rock face below resulting in an overhang of about 1-2 m. The failed block also had a series of stepped overhanging rock with another 2 m overhang at about the midpoint on the failed block. We estimate rough dimensions of the failed block at 20 m wide by 15 – 20 m high and with an average depth of 4 -5 m; the estimated rock volume is between 1,200 and 1,600 cubic metres.

Figure 1 – Source area before the rock fall (photo Jim Hegen).

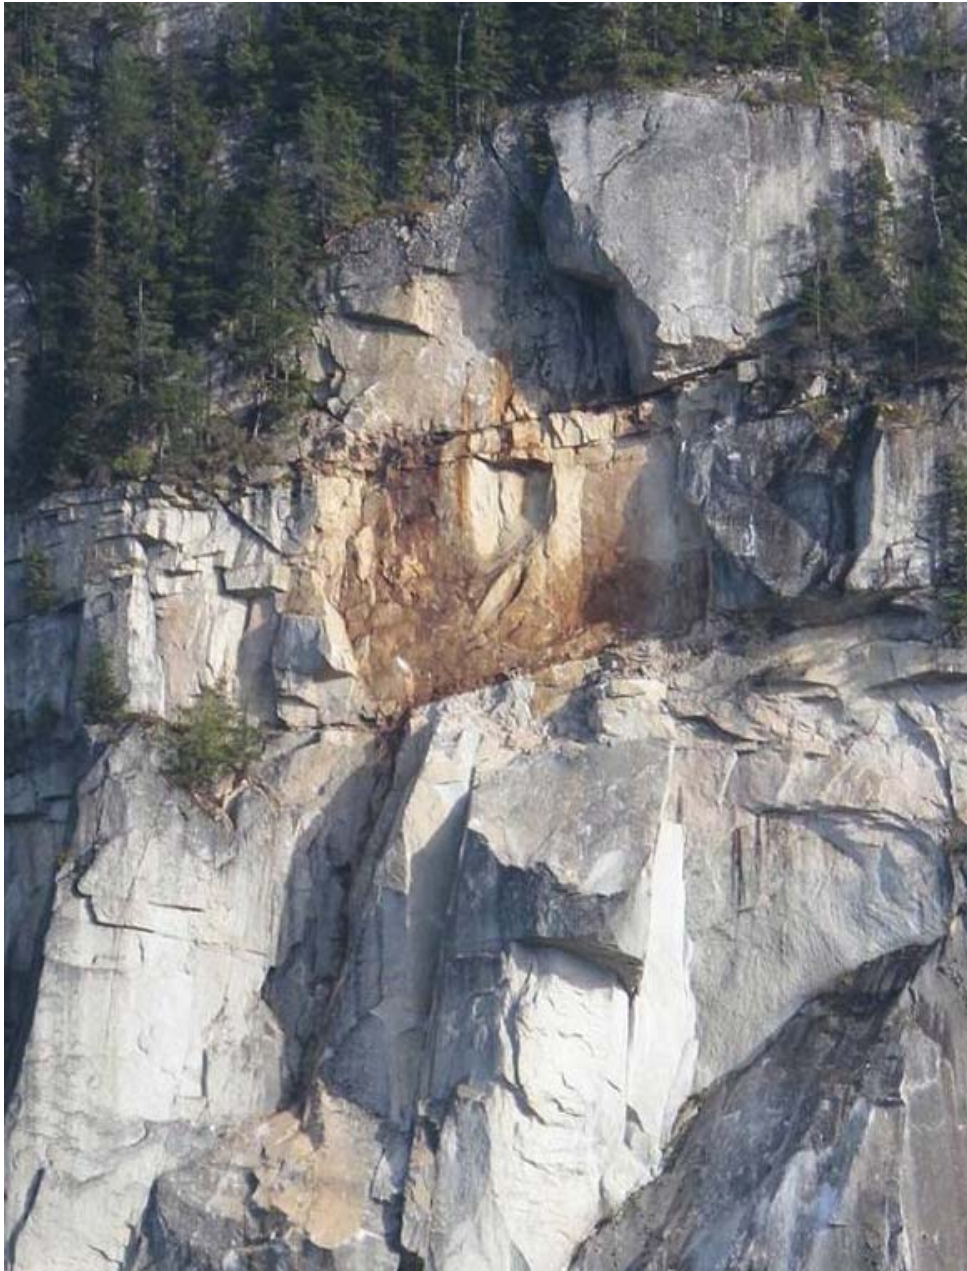
Review of photographs taken prior to the rock fall show that the failed block had a flat top that was vegetated by numerous mature trees estimated to be up to 10 m in height. It is likely that much of the root system of these trees had grown into the back release joint behind the failed block. Organic staining, soil, and root fragments are visible along the back scarp of the failure and within the remaining joints (ref. Figure 2).

Figure 2 – After the rock fall, note staining along back release joint (photo Jim Hegan)

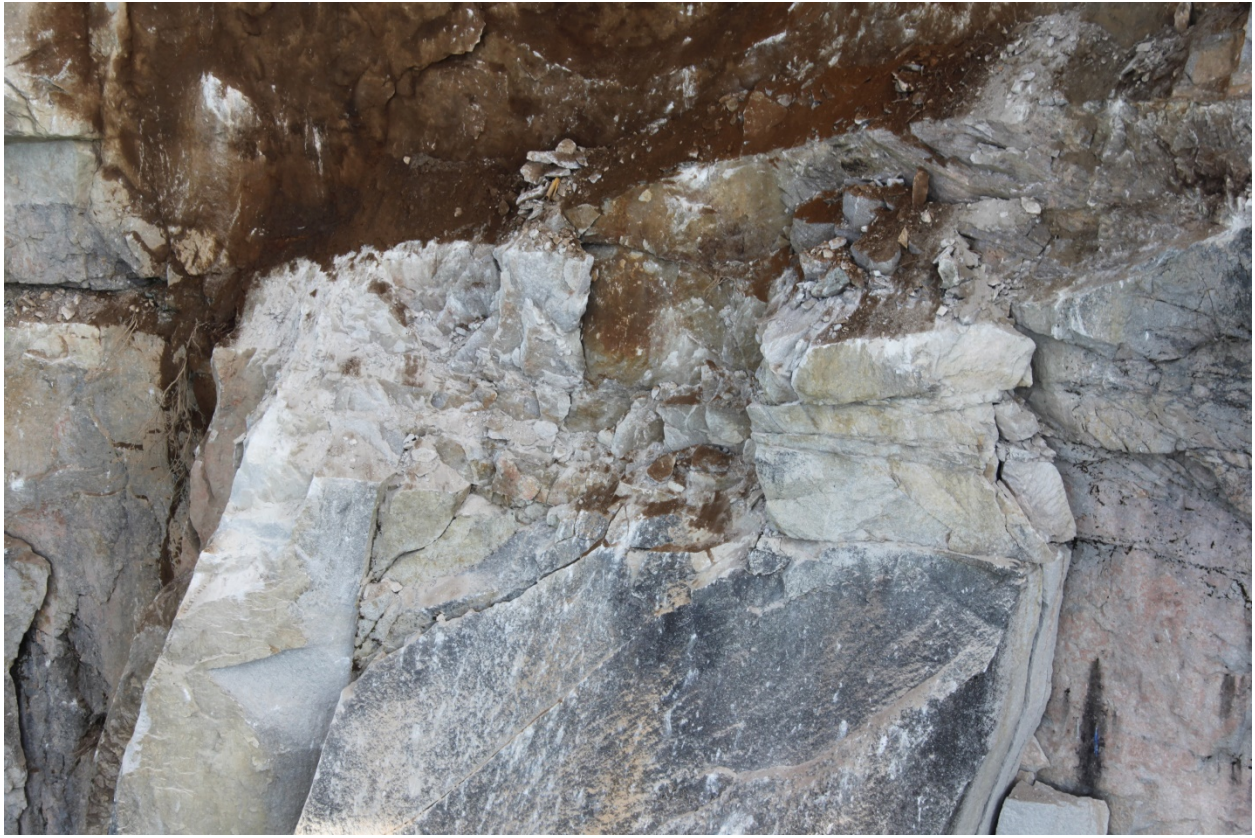
The rock which formed the ledge (or pedestal) on which the overhanging failed block was supported (Block B) was more fractured and weathered. The top of the pedestal rock that supported the failed block rock appears to have been crushed along the outer margin and may have failed in tension towards the

back (ref. Figure 3).

It appears as that the rock fall occurred as a result of root jacking behind the failed block (Block A) which in turn crushed the supporting weathered and fractured pedestal of rock (Block B) below Block A. Block A was completely detached on the backside and was likely on the brink of failure for some time as the roots jacked it outwards. This coupled with the completely detached geometry of Block A and overhanging nature of the front face would have caused the centre of gravity of the block to shift outward. This, in turn, would have induced additional downward pressure on the supporting rock pedestal. The supporting rock was highly jointed and slightly weathered and noted by climbers as being “loose”. The outward rotation would have overstressed the supporting rock mass and it eventually yielded to the imposed stress or pressure from Block A causing it to ultimately fail; resulting in possible small precursor rock falls. As this support was gradually lost, additional force would have been distributed to the limited area where Block A was affixed to the greater rock mass where it ultimately would have failed in compression and sheared off; this can be seen as the clean break in photographs (ref. Figure 3).

Figure 3 – Tightly spaced joints in area of Block B and where break occurred (at left)

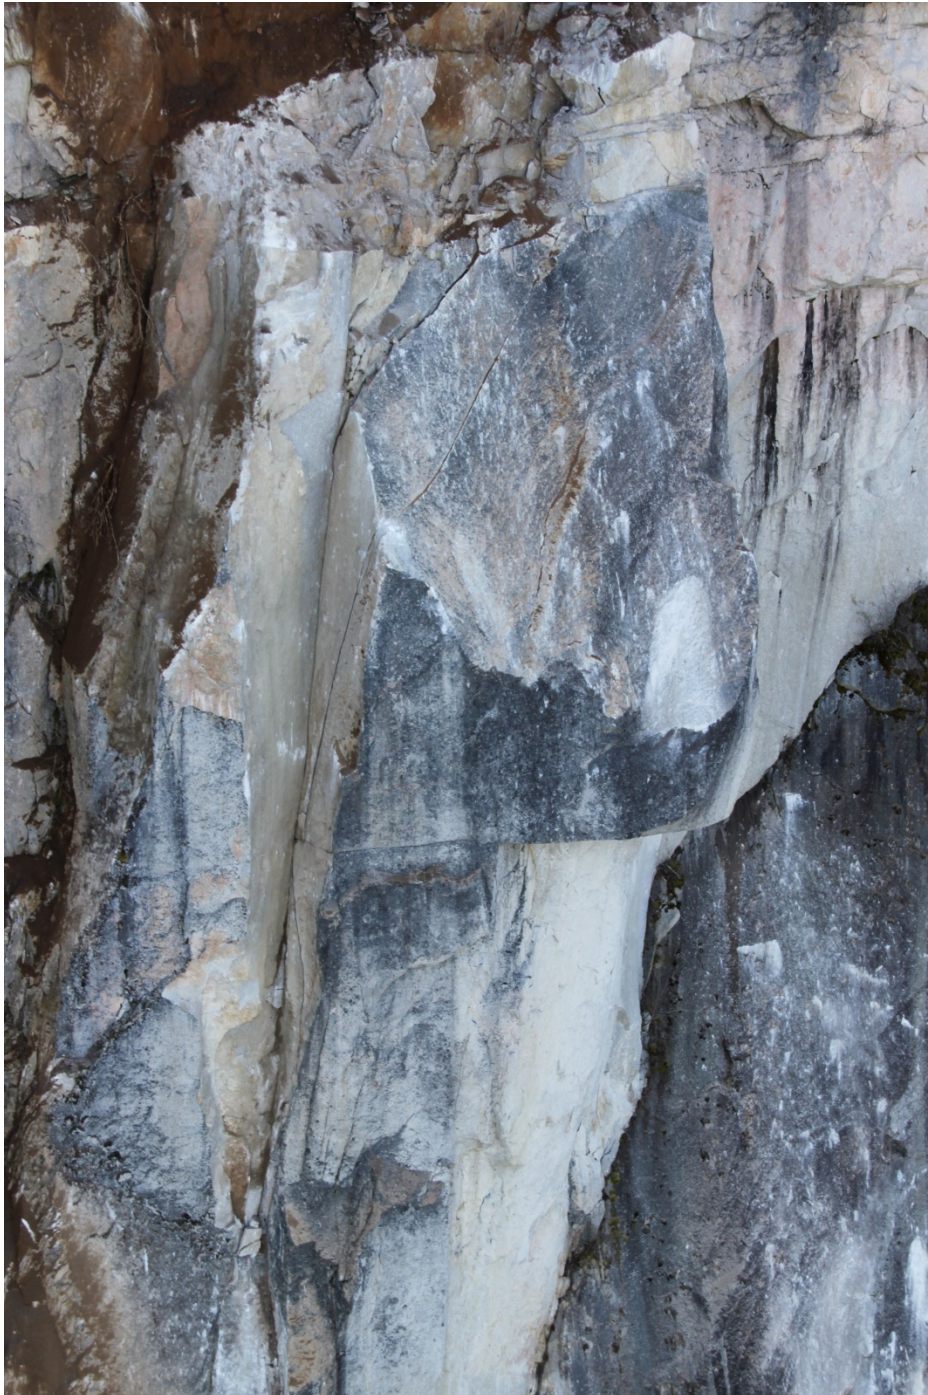
Below the rock ledge a wedge- like sliver of rock (Block C) with a vertical extent of close to 20 m failed in a steep open book or dihedral-like pattern (ref. Figure 4). It is not known if this failed prior to or as a result of the main rock fall.

Figure 4 – Steep wedge-like failure (Block C) below source area

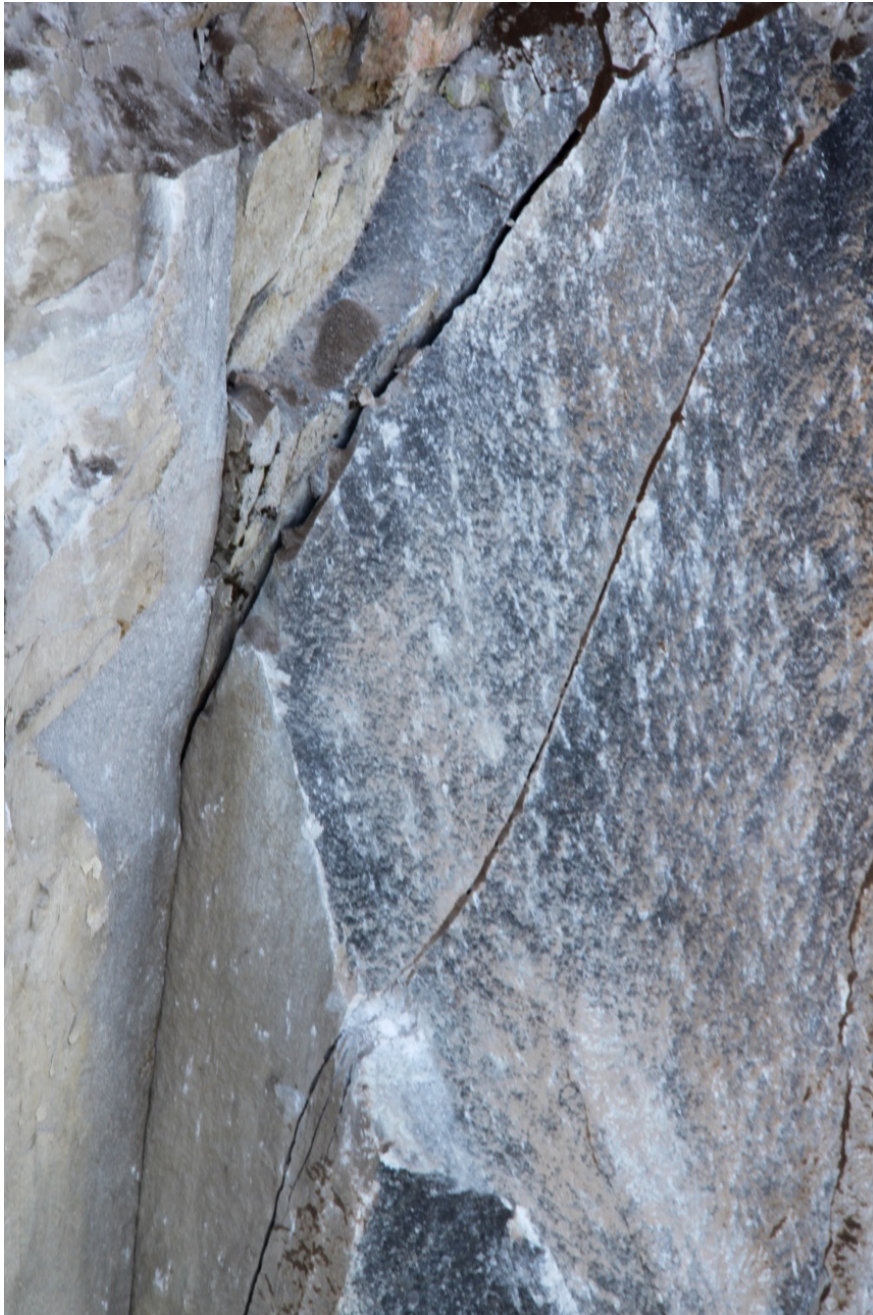
There was a significant impact to the “tooth” feature directly below the rock fall source area (Block D). The impact appears to have caused a new crack to open and intersect an existing near vertical fracture on the backside of Block D. This potential release fracture appears to have opened up somewhat compared to before the impact (ref. Figures 4 and 5).

As noted above, there was an impact to the “tooth” feature (Block D) located beneath the rock fall source area and a new crack appears to have opened. The fact that this feature took a direct hit during the rock fall and did not dislodge indicates some level of stability. However, further evaluation of this feature in the field should be considered.

Figure 5 – Impact location on Block D and open joints

4. A geotechnical assessment of the source area by a rock mechanics expert to determine the extent of the damage to the impacted rock on the “tooth” feature (Block D) and to determine the overall stability of the larger block up and west of the failure area (Block E) should be considered. We expect that this could be carried out by rappelling down to the source area by rope from the top of the North Wall.

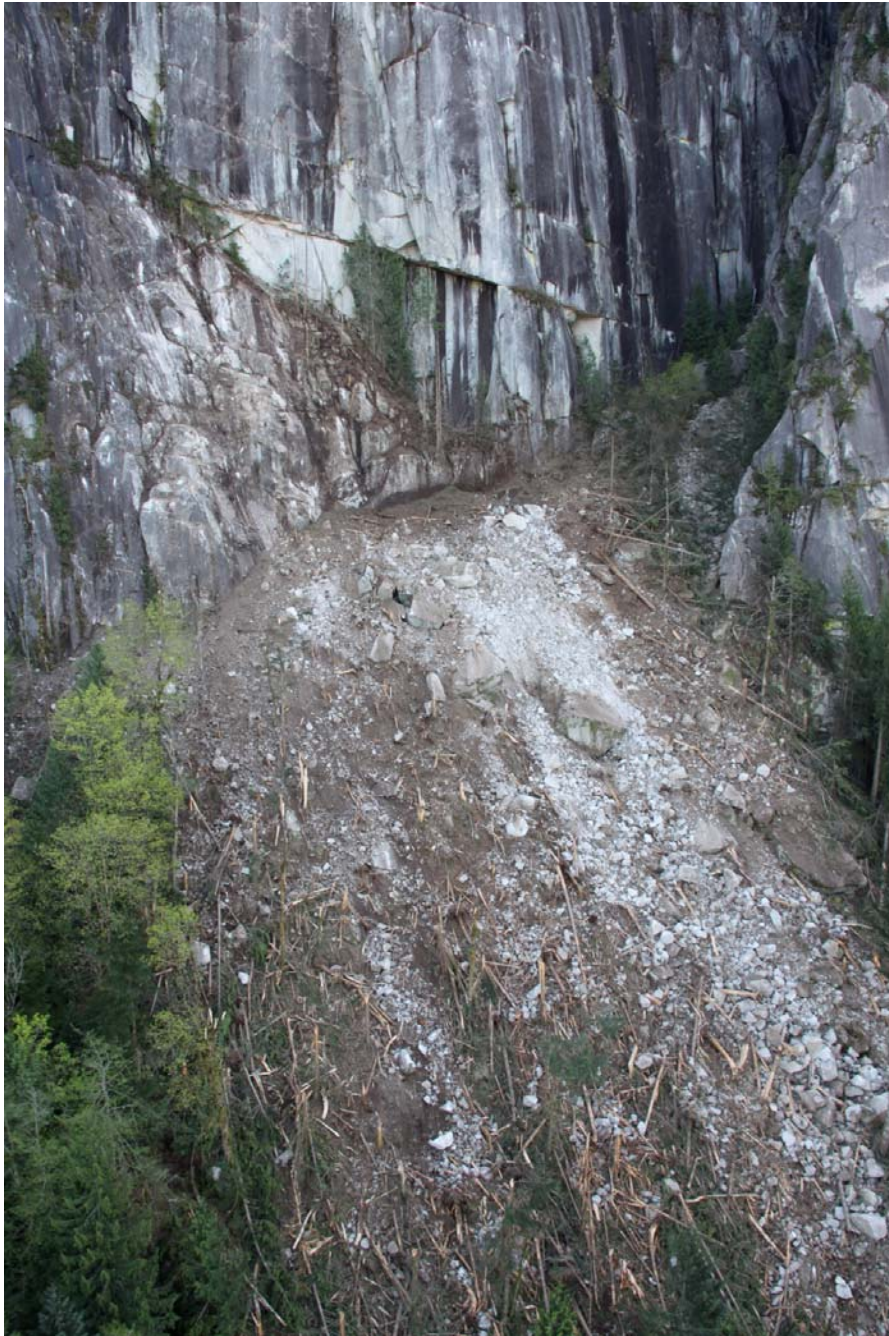
It is estimated that the failed block free fell about 310 m before impacting the ramp-like or apron feature at the base of wall and scattering across the talus slope. Prior to the rock fall this area was treed. We expect that upon impact the rock was broken up into smaller blocks and fragments and that these were projected laterally from the apron destroying the nearby forest before being deposited over the talus slope. The apron was completely stripped of trees and loose rock (ref. Figure 6).

Figure 6 – Impact zone on apron at base of slope and deposition on talus

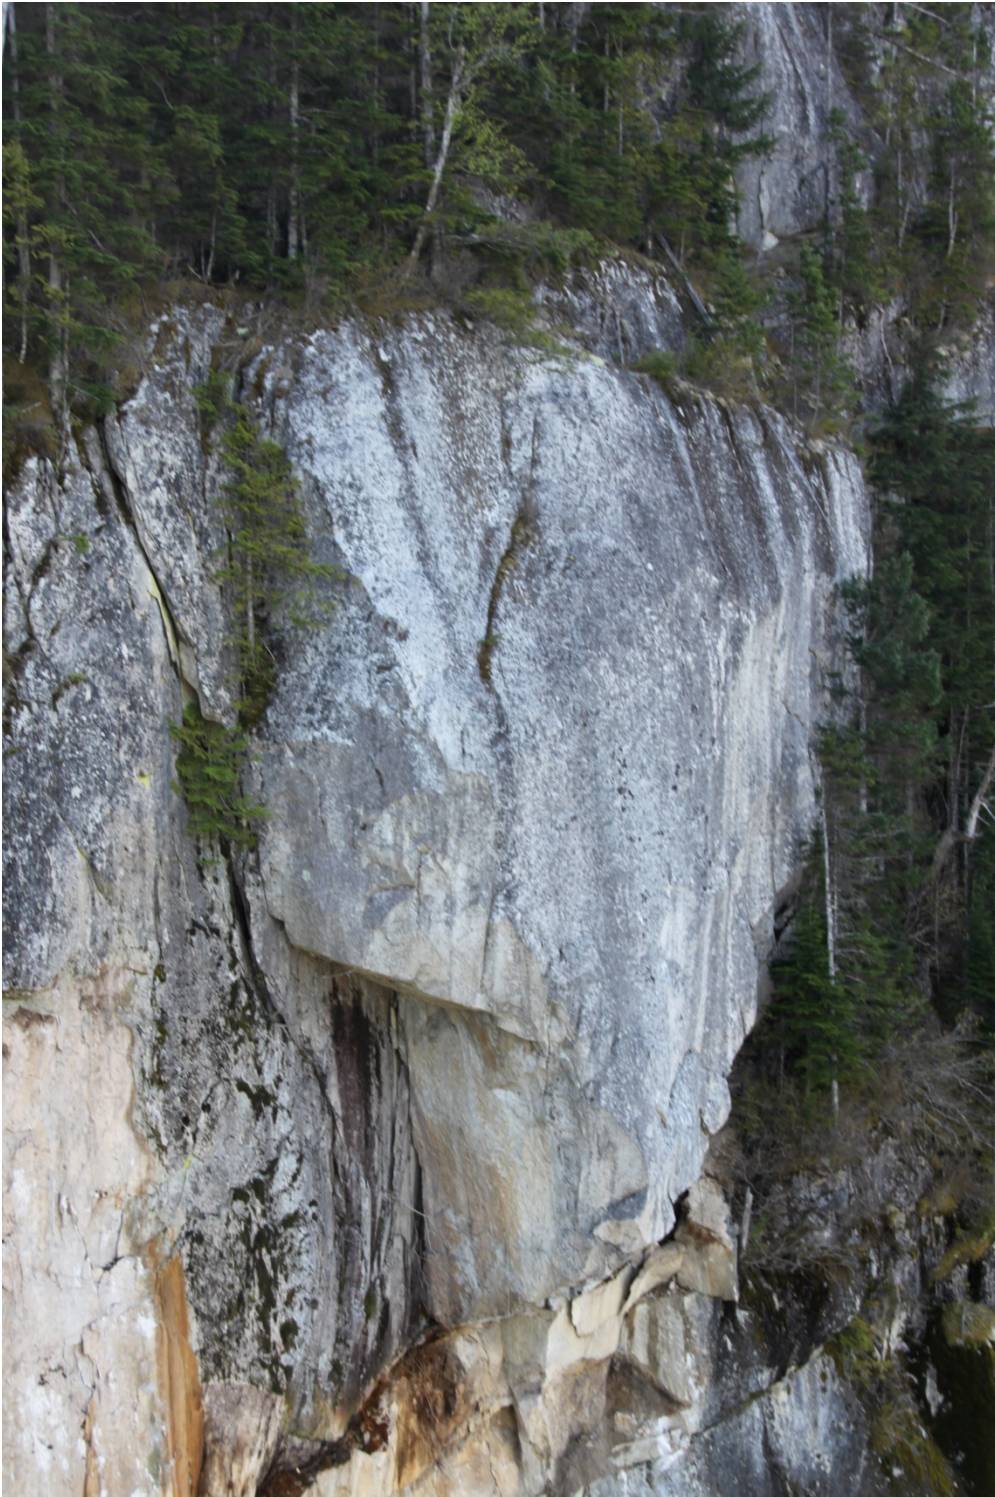
There is a block above and to the west of the source area (Block E) which may have been affected by the loss of Block A (ref. Figure 7). It appears as though Block A did not provide much support to this adjacent block, however, there was likely some contact between these blocks. The exposed back release joint behind Block A extends behind Block E. As well there are established trees on top of Block E. It was not possible to view the joint from the top of Block E from the helicopter because of the trees. Further evaluation of this feature in the field should be considered.

Figure 7 – Existing overhanging block (Block E) above and west of the source area
